AGARD Corrosion Handbook Volume 1 Aircraft Corrosion: Causes and Case Histories

AGARDograph No.278
AGARD CORROSION HANDBOOK
VOLUME 1

AIRCRAFT CORROSION: CAUSES AND CASE HISTORIES

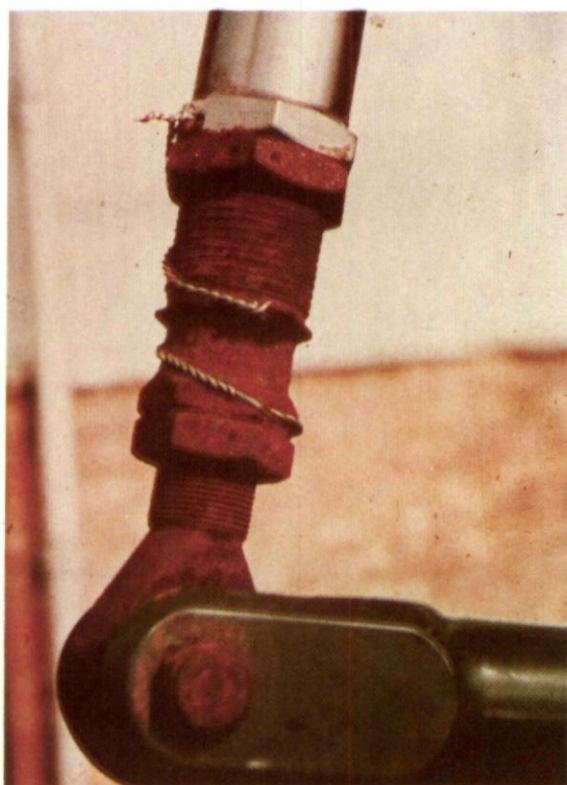
Most of the common engineering metals and alloys produce characteristic corrosion products which allow corrosion to be recognized fairly easily. Probably the best-known form of corrosion occurs on non-stainless iron and steel and is easily recognized by the familiar red iron rust (Figs. 7-1 and 7-2). Figure 7-1 shows rusting on a steel track rod adjuster and eye end, originally cadmium plated but operating in an exposed environment. The cadmium had presumably been totally sacrificed after loss on threads during assembly or maintenance. Use of a supplementary protective material should have prevented this. Figure 7-2 shows a steel jet pipe end cap liner which had been subjected to high temperature oxidation over a long period of time. In this figure the blistering and flaking of a surface protective coating is apparent, and the formation of red rust products in the underlying steel can be seen. The materials chosen for this application had simply proven unsuitable for the environment, though quite possibly they were the best available when the design was established. The fact that the aircraft life had been extended, and these components had been required to operate for much longer times than originally intended is also an important factor.

Fig. 7-1 Rusting on a steel track rod adjuster and eye after damage occurred to the protective cadmium plating

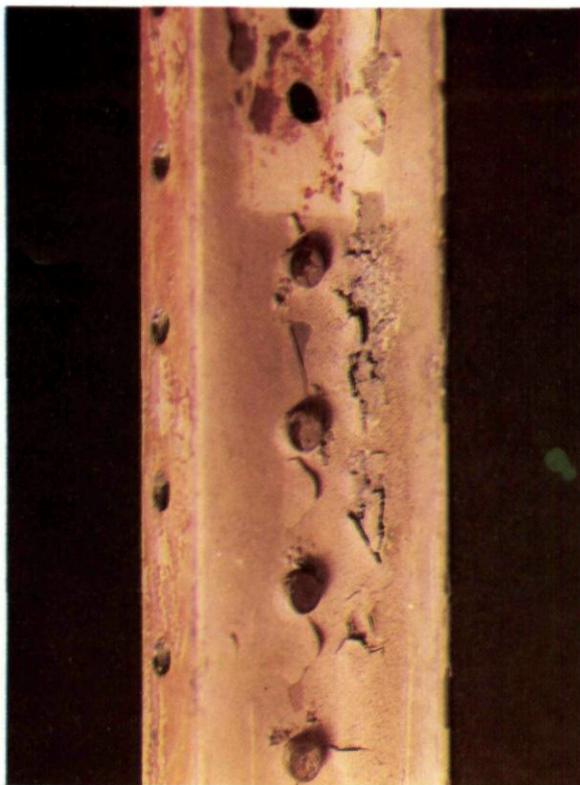
The corrosion products of aluminium and magnesium alloys are evident as white to grey powdery deposits, the latter are often of a fluffy or granular nature. Figure 7-3 shows the surface corrosion damage to an aluminium alloy stringer, where the chromate pre-treatment and primer coat had failed, probably through aging and exposure to moisture. Early identification of aluminium or magnesium corrosion is essential, and frequently the first indications are flaking or blistering of the surface finish. Figure 7-4 shows an area of general surface corrosion on a magnesium alloy skin of a helicopter on which the chromate pre-treatment had locally failed.

Fig. 7-3 Flaking of the chromate pre-treatment and primer on an aluminium alloy stringer and corrosion of the exposed metal

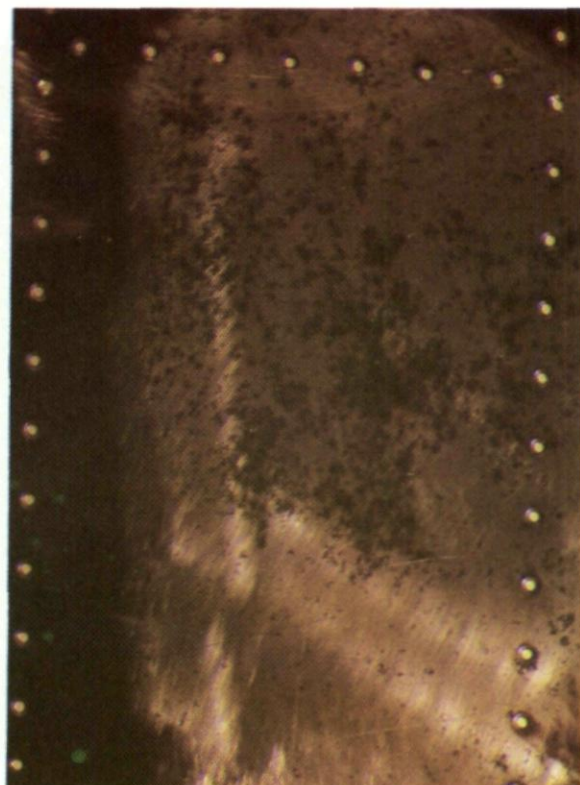
Fig. 7-4 Uniform corrosion in a magnesium alloy helicopter skin after damage to the chromate pre-treatment

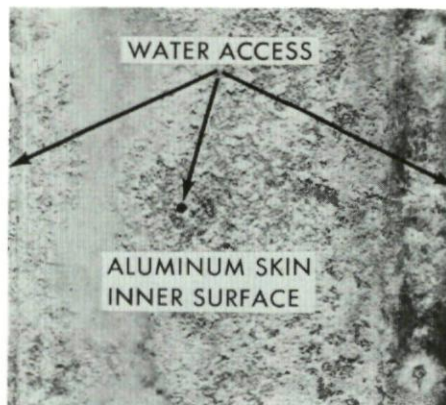
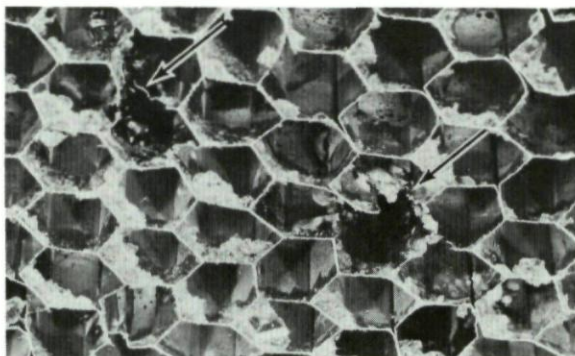
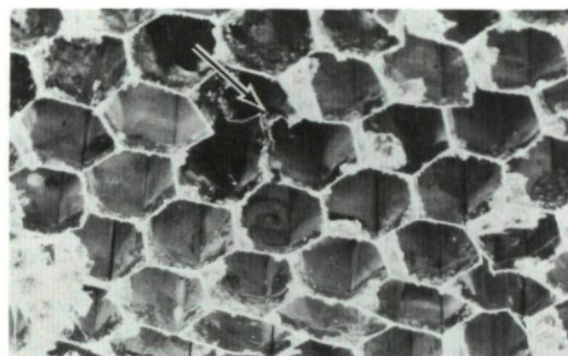
Fig. 7-5 Corrosion damage in an aluminium alloy honeycomb structure from a fighter aircraft

- (a) Inner surface of the aluminium skin showing perforations.
- (b) Foam rubber filler material.
- (c) and (d) Arrows point out areas of severe corrosion damage in the honeycomb.

Early attention to uniform corrosion damage is particularly important where the metal skin is used as an outer layer of a honeycomb sandwich structure, or closed box structure. Failure to do so may lead to penetration of the skin by corrosion, and the entry of water or other corrodents into the internal structure. Figure 7-5 shows the corrosion damage to an aluminium honeycomb structure from a fighter aircraft. Figure 7-5(a) shows heavy corrosion on the inner surface of the aluminium skin, with holes which allowed the ingress of water. Figures 7-5(c) and 7-5(d) show areas of corrosion damage to the aluminium honeycomb, which are indicated by arrows. Figure 7-5(b) shows a sample of foam rubber filler material which formed a layer between the skin and the honeycomb. It is uncertain whether the rubber in this case contributed to the corrosion reactions, but the operators of this particular aircraft did note that the rubber was usually not present. This simply serves to point out that all material combinations should be evaluated with respect to corrosion before a design is finalized, since one material may contribute to the corrosive environment of another.

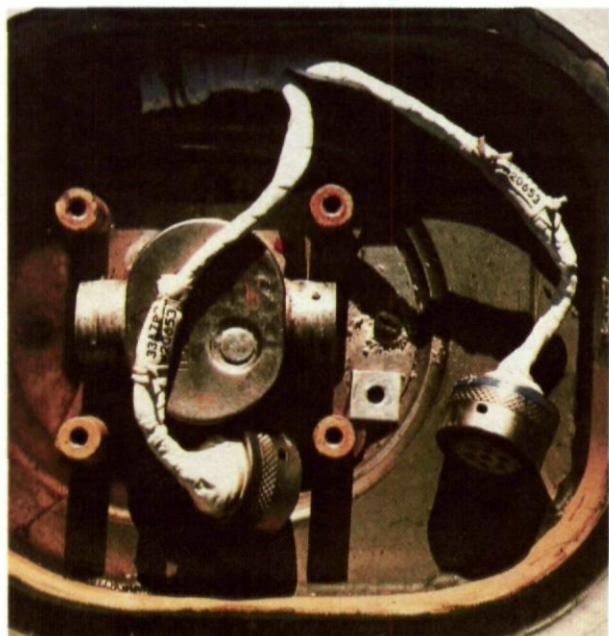
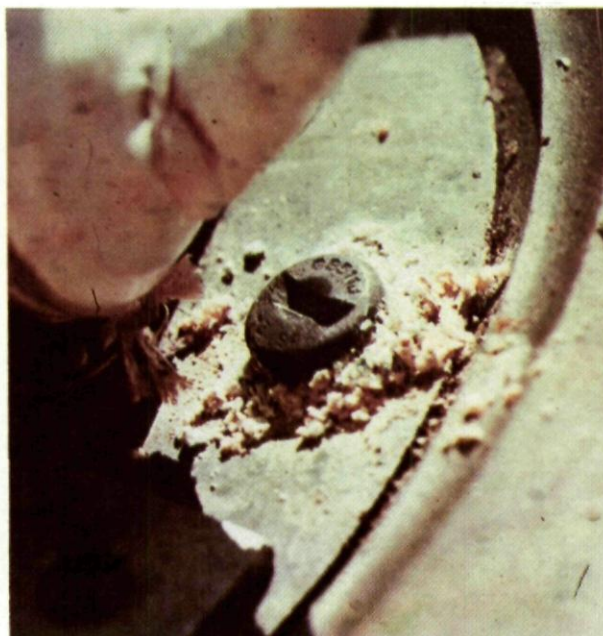
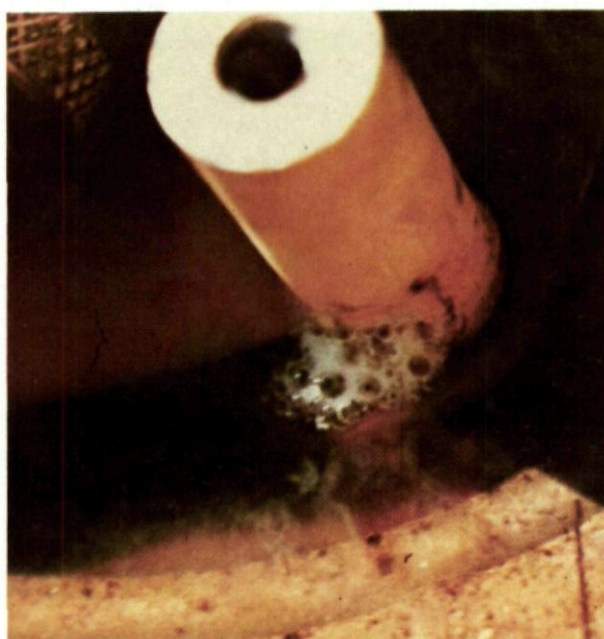
The need to prevent the ingress of water and other corrodents to internal structure and equipment is nowhere more important than with electrical and avionics equipment. In the interests of obtaining specific electrical characteristics, the materials used are often inferior in terms of corrosion resistance, and serious corrosion problems and often malfunction of equipment can occur if the equipment is not properly sealed. Figure 7-6(a-c) shows examples of corrosion of electrical equipment in a military aircraft due to water intrusion around the access door. The general reddish-orange discolouration of the compartment walls and floor, in Figure 7-6(a), indicates that uniform corrosion has occurred in these areas. The close-up photographs of Figure 7-6(b) and -6(c) show local eruptions of corrosion products around a screw and binding post, which are probably examples of galvanic corrosion and crevice corrosion.

Fig. 7-6 Corrosion in a container used to house electrical equipment

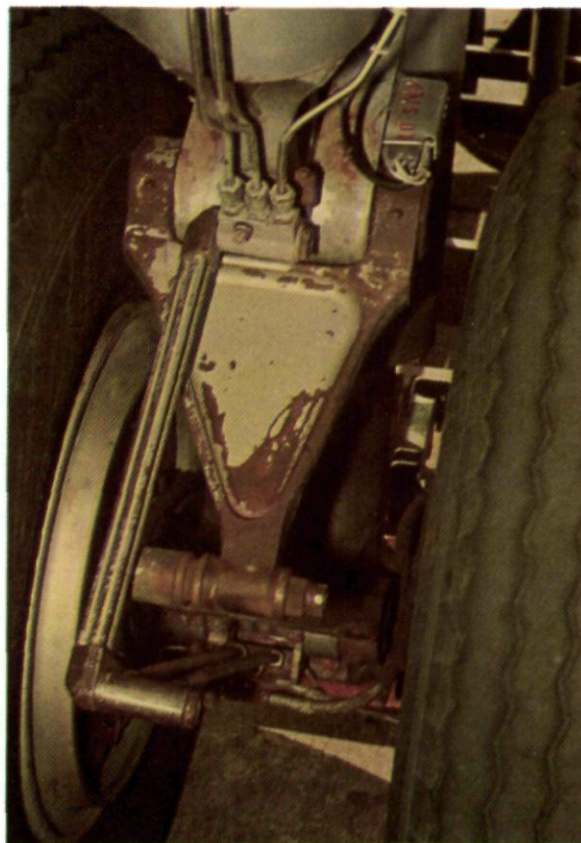
Erosion-corrosion problems can be quite severe in transport aircraft operating in hot desert climates. Though dry in the sense of having low rainfall, desert areas are nevertheless often very humid, especially at night. High temperatures accelerate corrosion, distort skin surfaces and crack protective finishes, while dust and sand often containing a high proportion of salt erode surface finish and also mix with oils, grease and hydraulic fluid to form extremely abrasive compounds. Loose stones and rocks thrown up from temporary landing strips damage protective finish leaving areas of bare metal open to corrosive attack. Figure 7-7 shows erosion-corrosion damage to the undercarriage components of a transport aircraft as a result of operation from a desert landing strip. Damage to the protective coating system by stone impact and sand erosion has led to exposure of the bare metal which then continues to deteriorate by a combination of corrosion and erosion.

Fig. 7-7 Erosion-corrosion damage on the undercarriage of a transport aircraft

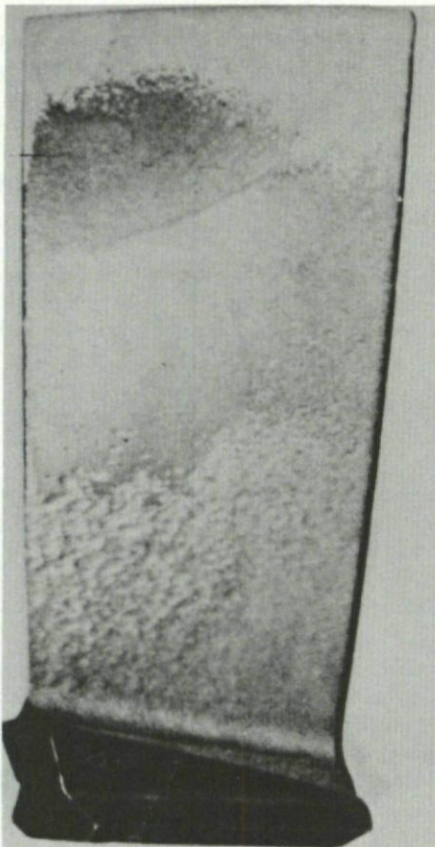
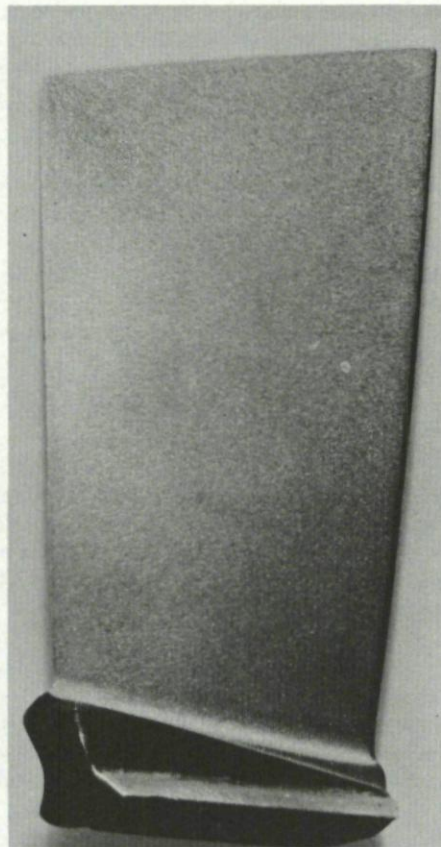
Erosion-corrosion is a common form of damage to aircraft propellers and turbine engine components operating either in the intake air stream, or in the hot gas path. Components such as impellers, compressor blades, turbine blades, nozzles and guide vanes are particularly prone to damage. Figure 7-8(a) shows erosion-corrosion damage on the concave surface of a compressor blade from a fighter aircraft engine after 16.5 hours in an erosion test cell. This particular blade was protected by a proprietary protective coating, applied by a vapour deposition process. Figure 7-8(b) shows a similar blade protected with a bias sputtered TiCrC coating after a similar 16.5 hour exposure in the test cell. A great number of hard, erosion resistant coatings are available for protection of engine coatings, and a great deal of research and development on new coatings continues.

Fig. 7-8 Erosion-corrosion damage on the airfoil of a fighter aircraft compressor blade

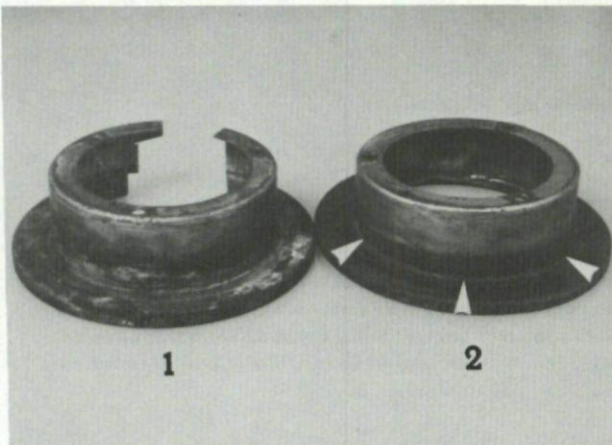
(a)

The brake disc assemblies were removed from both main wheels of a light single engine aircraft (Fig. 7-9(a)). Both brake disc assemblies were severely corroded in the fillet radius area between the disc and the sidewall, and there was a 12-15 mm band of corrosion around the outside surface of the wall as shown in Figure 7-9(a).

Fig. 7-9 Corrosion failure of a brake disc assembly

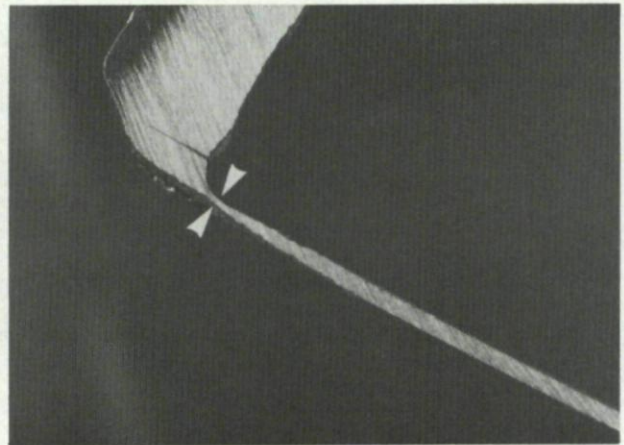
(b)

The brake disc assembly number 2 had failed around the sidewall circumference adjacent to the disc; this area was severely weakened due to corrosion to the extent that the wall thickness at the failed section was reduced to approximately one-quarter of the original thickness. Figure 7-9(b) shows the corresponding section through the disc and sidewall of the unfailed assembly, number 1. Even though this particular unit had not failed, a serious loss of material had occurred leading to a reduction of sidewall section thickness, as indicated by the arrows in Figure 7-9(b).

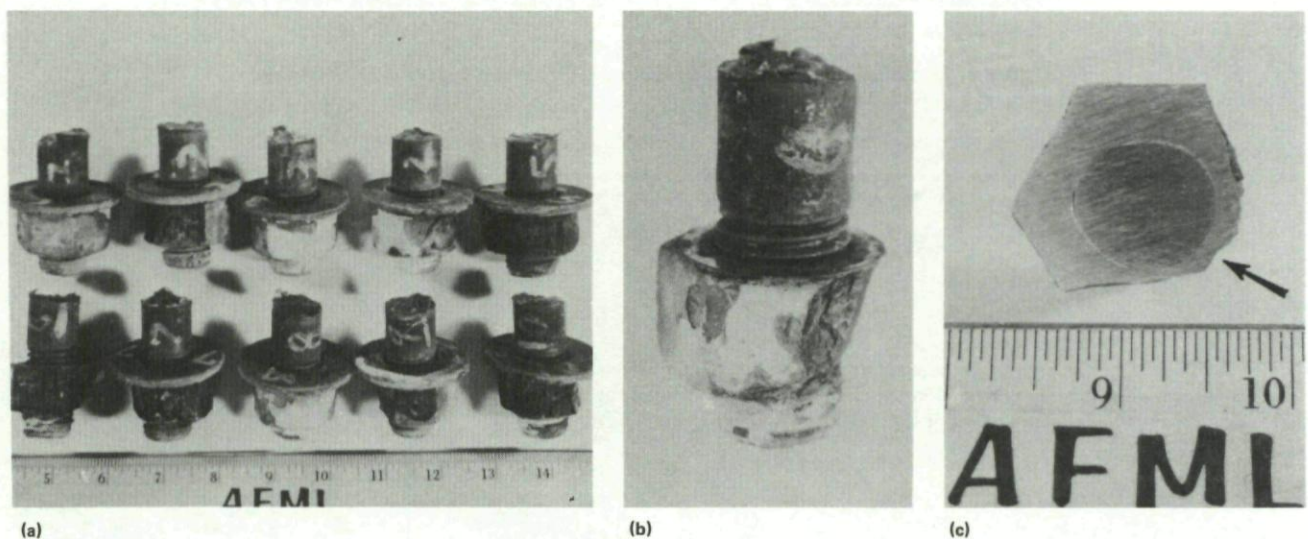
Visual and optical examination verified that considerable corrosion existed on all part surfaces. However, the most severely affected areas were found to be on the surfaces of the nuts, as shown in Figure 7-10(b). Cross-sections through the nuts and bolts revealed the severity of corrosion, and showed that nearly one-third of the cross-sectional area on all ten nuts had been lost to corrosion. The depth of corrosion, in some areas, extended almost to the bolt surface, as shown in Figure 7-10(c).

Fig. 7-10 Corrosion of structural steel fasteners

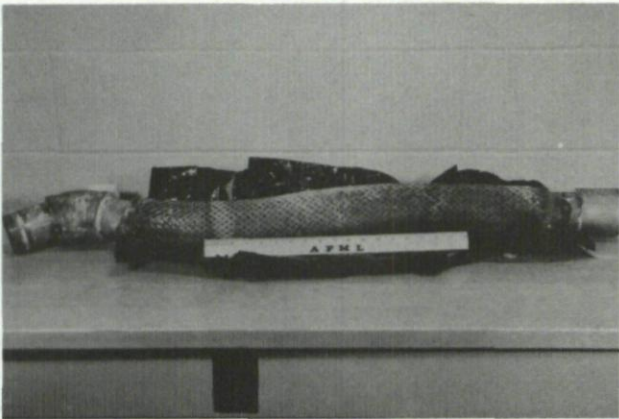
(a)

Visual examination of the flexible stainless steel pipe, Figure 7-11(a), revealed the outside surface to be covered with a light tan powdery residue or corrosion product. A dark brown residue was found on the inside surface when the pipe was sectioned (Fig. 7-11(b)). The wire mesh was stripped from the convoluted flexible pipe and large cracks were found running circumferentially around the inside or small radius bends of the convolutes (Fig. 7-11(c)).

Fig. 7-11 Hydrofluoric acid corrosion of an austenitic (316) stainless steel pipe

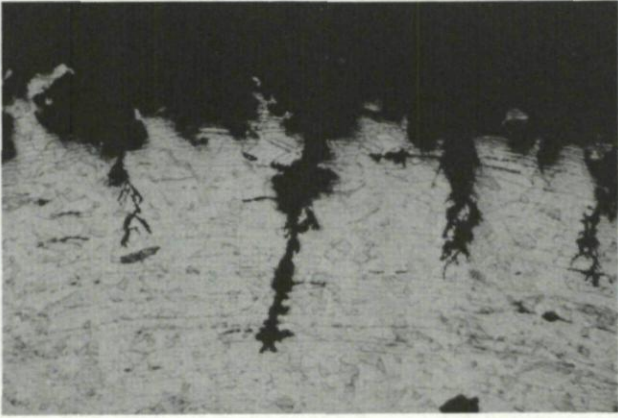
(d)

Microscopic examination of the convoluted pipe, Figure 7-11(d), showed that pitting had occurred beneath the corrosion products and that stress corrosion cracks had initiated at the base of the pits. The stress corrosion was observed only on the inside or small radius bends of the convolutes, while pitting was observed over the entire internal surface of the flexible pipe.

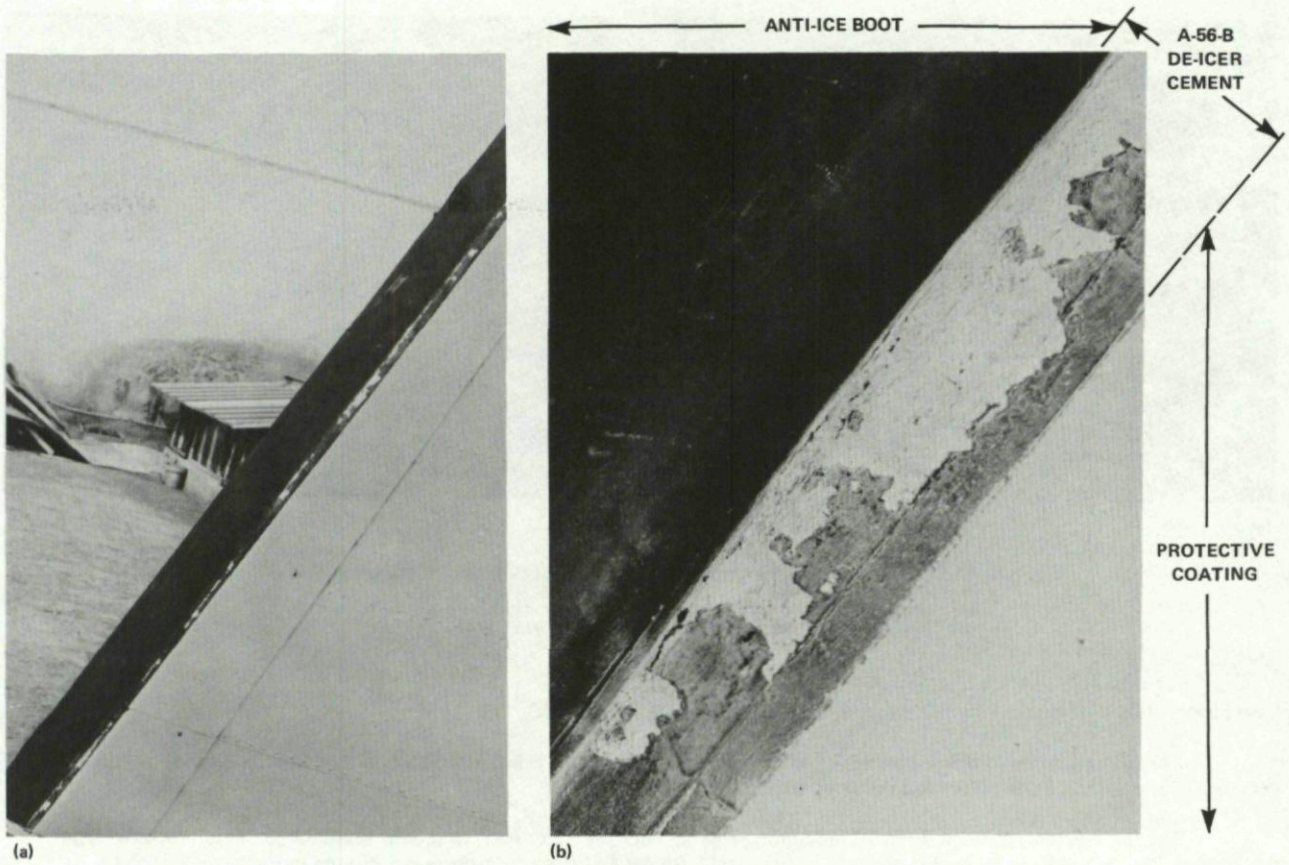
Fig. 8-4 Galvanic corrosion in an aluminium alloy skin due to contact with a conductive cement

The personnel involved in the repair and overhaul of this aircraft recommended the use of a rain erosion resistant anti-static coating system (MIL-C-7439) to replace the conductive de-icer cement. The important requirement is to avoid the use of a conductive cement in exposed contact with the aluminium. In the example cited, corrosion damage to the 2024 aluminium would have been much reduced had the bare cement been covered by a protective coating to prevent mechanical damage to the cement and to prevent the intrusion of water.

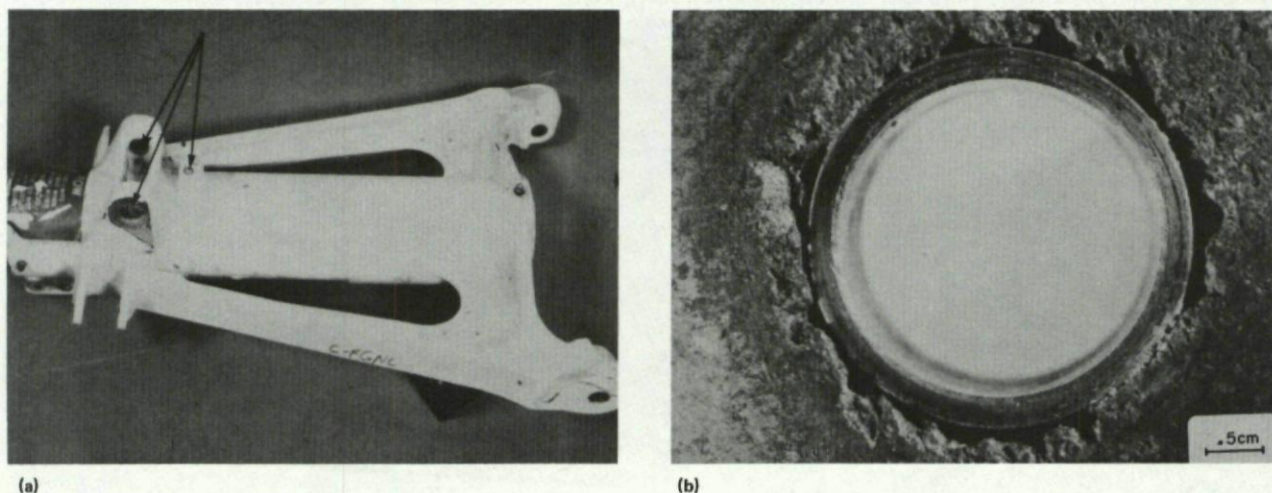
A nose gear strut assembly from an executive twin-engined aircraft was found, during a visual inspection, to be severely corroded around the drag brace attachment lugs. The strut and the areas of corrosion attack are shown in Figure 8-8(a). The strut assembly was a magnesium alloy casting and the lugs contained cadmium plated low alloy steel bushings. The steel type was not revealed to AGARD, but was reported to contain a high chromium content.

Visual inspection of the corroded lugs (Fig. 8-8(b)) showed that the steel bushings were undamaged while severe corrosion of the magnesium alloy which was in contact with the steel had occurred. The preferential corrosive attack of the magnesium at the magnesium/steel interface suggests that the damage was caused by galvanic corrosion, where the magnesium formed the anode of the electrolytic cell and the steel the cathode. The aircraft in question had been operated in a marine environment, and the moist salt laden atmosphere would have contributed to the problem. However even a milder environment would likely give rise to a similar problem given sufficient time.

Both cadmium and zinc type coatings protect steel by anodic protection, which involves the sacrificial corrosion of the anodic coating to prevent or minimize corrosion in the cathodic steel. However in sea water magnesium alloys are strongly anodic with respect to both steel and cadmium, and therefore cadmium serves no useful purpose in this case other than to protect the bore of the steel bushing. It is doubtful whether magnesium alloy castings would be selected at the present time for a component such as this nose gear strut, which experiences severe conditions and aggressive environments in service. However, in other cases it is important to provide an insulating interface material between magnesium and any steel parts.

Fig. 8-8 Galvanic corrosion between a steel bushing and a cast magnesium alloy nose gear strut

- (a) General view showing areas of attack (arrows).
- (b) Close-up of corrosion adjacent to the cathodically protected steel bushing. (Mag. x 2)

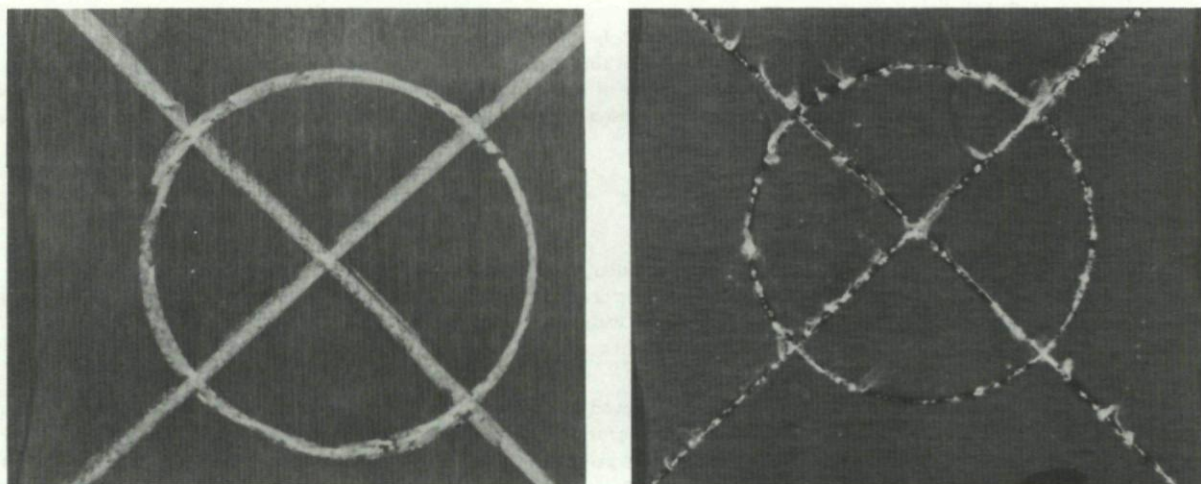
In order to verify that the lost disc might be associated with the pencil marking, laboratory specimens of the high strength aluminium alloy skin material were marked with a conventional graphite pencil and with a grease pencil, and were then exposed to salt mist accelerated corrosion testing. One week of exposure showed no effect on the grease pencilled panel (Fig. 8-9(a)) while the graphite pencilled panel showed severe corrosion damage (Fig. 8-9(b)).

Whether the reported "lost disc" actually fell out of the wing cannot be ascertained, but nevertheless the laboratory trials demonstrate unequivocally that severe galvanic corrosion can occur, even when a thin film of graphite comes in contact with a high strength aluminium alloy. Table 3-2 shows that graphite (carbon) is one of the most noble materials, and will give rise to a strong electrochemical potential when coupled with aluminium alloys. Marking of any aerospace hardware should only be performed with safety-checked markers, such as grease pencils.

Fig. 8-9 Galvanic corrosion in aluminium alloy wing skin due to conductive markers

- (a) Panel after 7 days exposure to salt mist when a grease pencil was used.
 (b) Panel after the same exposure when a graphite marker was used, showing galvanic corrosion.

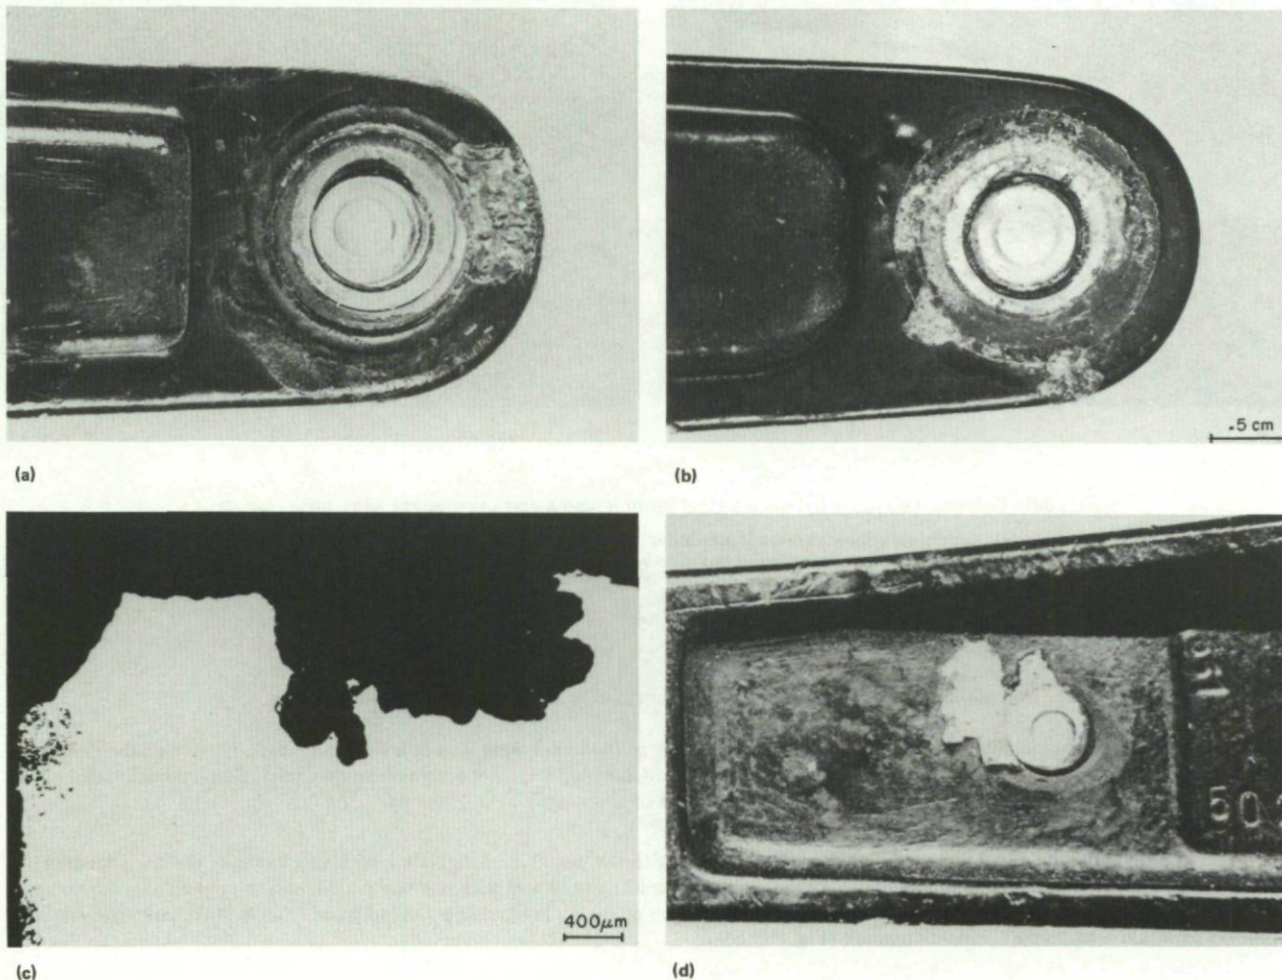
The control levers of a flap deflection mechanism of an aircraft were made from a magnesium casting alloy with a nominal composition Mg - 6%, Zn - 2%, Th - 0.75 Zr, similar to ZH62A. The levers were protected with a zinc-chromate primer and an epoxy top-coat. Galvanic corrosion was found in the levers in a socket where steel balls had been located. The ends of the lever arms are shown in Figures 8-10(a) and 8-10(b), which also show the corrosion damage. Figure 8-10(c) shows a cross-section through the lever arm in the corroded area and shows deep cavities due to this galvanic corrosion.

Fig. 8-10 Galvanic corrosion in a cast magnesium alloy flap control lever arm

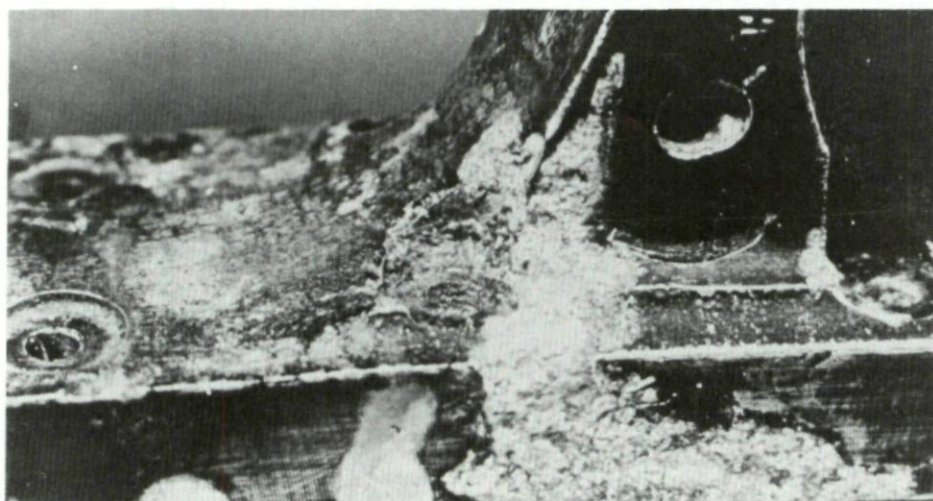
For active metals uniform exposure of a large surface area to a corrosive medium would tend to cause uniform corrosion. Pitting of an active metal will therefore occur as a result of local wetting, or defects in a protective coating which allow very localized exposure. A severe case of pitting corrosion damage to an active metal component is shown in Figure 9-1(a). The component was a magnesium alloy casting used as a helicopter structural cleat, and this was originally chromated and sealed. The protective treatment was damaged locally, possibly by the tools used in applying the fasteners, and not repaired. A similar example is illustrated in Figure 9-1(b) which shows a corroded magnesium alloy casting of a stringer end cap. This was also chromated and primed, but severe pitting corrosion occurred, probably due to failure of protection by aging and exposure to moisture.

Fig. 9-1(a) Severe pitting in a magnesium alloy casting

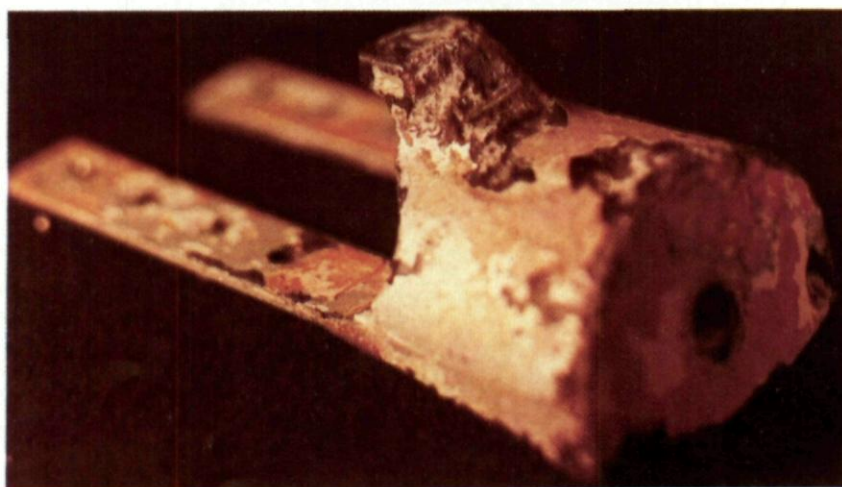
Fig. 9-1(b) Severe pitting in a cast magnesium alloy stringer end cap

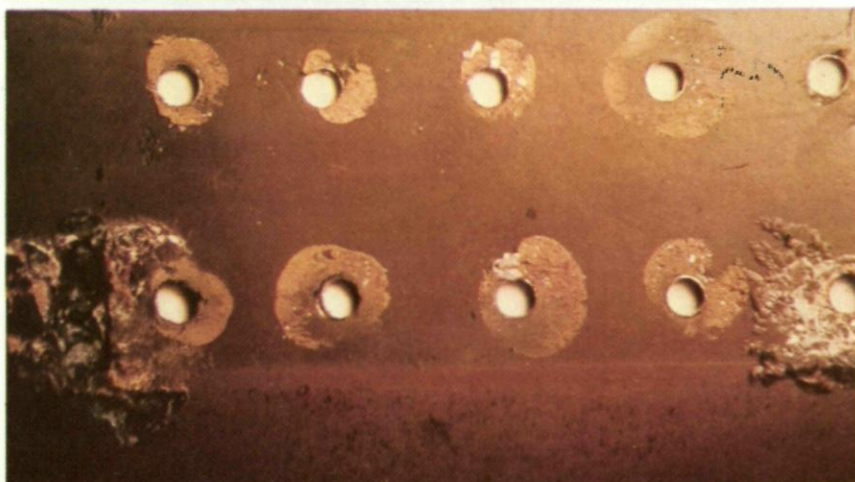
(a) Dismantled joint in a magnesium alloy panel.

Some examples of crevice corrosion are shown in Figures 9-2(a), 9-2(b) and 9-2(c). Figure 9-2(a) shows a corroded and perforated magnesium panel in a dismantled joint area from a transport aircraft structure. The corrosion damage was due to inadequate sealing. Figure 9-2(b) presents a similar case of crevice corrosion at the interface of a magnesium alloy skin joint, which was also due to inadequate sealing. In both examples the most severe damage is away from the edges of the fastener holes which suggests that galvanic corrosion was not the major factor. Figure 9-2(c) shows a situation where both galvanic corrosion and crevice corrosion contributed to the damage. The corrosion damage has occurred at the junction between a magnesium alloy floor panel and aluminium alloy frames and angle plates. This problem was probably aggravated by poor drainage conditions, and inadequate sealing and surface protection.

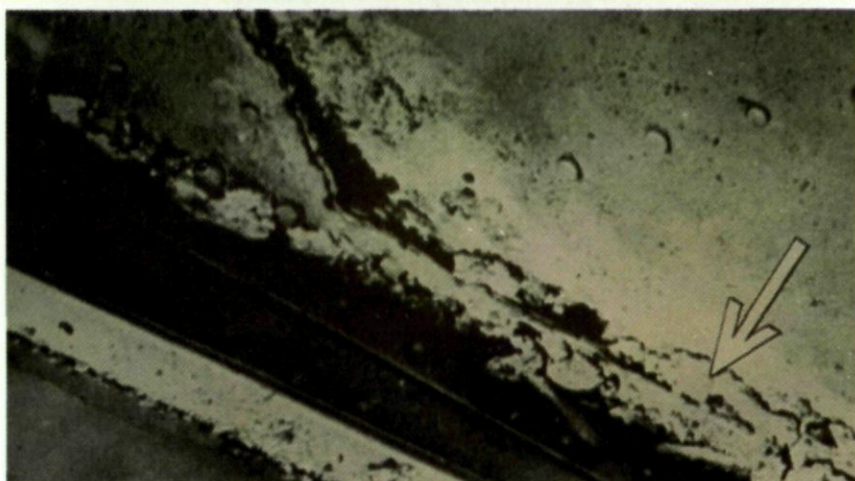
(b) Crevice corrosion in a magnesium alloy skin joint due to inadequate sealing.

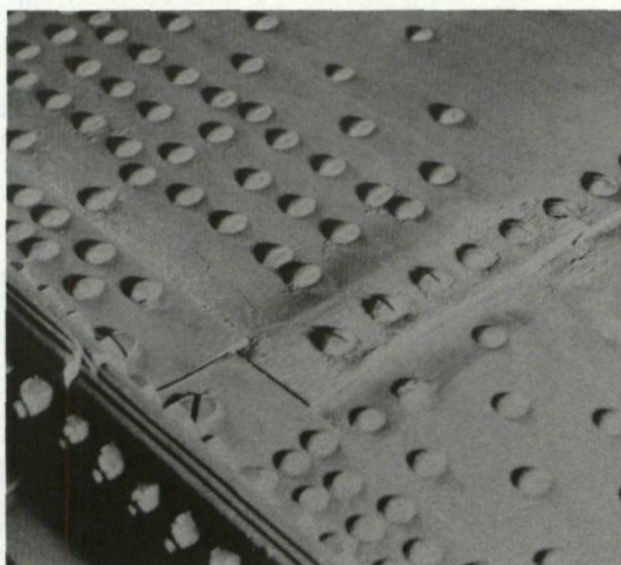
(a) Crevice corrosion in aluminium lap joint.

Crevice corrosion may be particularly severe with magnesium alloys since they are the most anodic of the common airframe structural alloys, however similar problems also exist with aluminium alloys. Figures 9-3(a), 9-3(b) and 9-3(c) show examples of crevice corrosion in the outer wing coupling flange of an older type small transport aircraft which had been operating in the Mediterranean region. The damage was observed during routine visual inspection, and subsequently x-ray inspection was used to measure the depth of corrosion in the different areas of structure. The structure was predominantly aluminium alloy sheet and flanges, with steel fasteners, and the structure was protected by a titanium dioxide (TiO_2) pigmented paint finish. Crevice corrosion is evident between the aluminium alloy flanges and sheet, and at the aluminium lap joints (Fig. 9-3(a)). Corrosion cavities were also observed under the bolts and nuts (Figs. 9-3(b) and 9-3(c)), and the corrosion can be seen to extend beyond the area of contact of the fasteners. Measurements of the depth of corrosion showed that this was greatest under the heads of the bolts and nuts, rather than at the immediate edges of the fastener holes. This suggests that the crevice effect was probably at least as significant as the galvanic effect in this case. The corrosion repair work led to this aircraft being out of commission for a reported "long period", although the precise details were not available. The repair work involved the use of a pigmented zinc chromate primer and top coat, in place of the TiO_2 finish used originally.

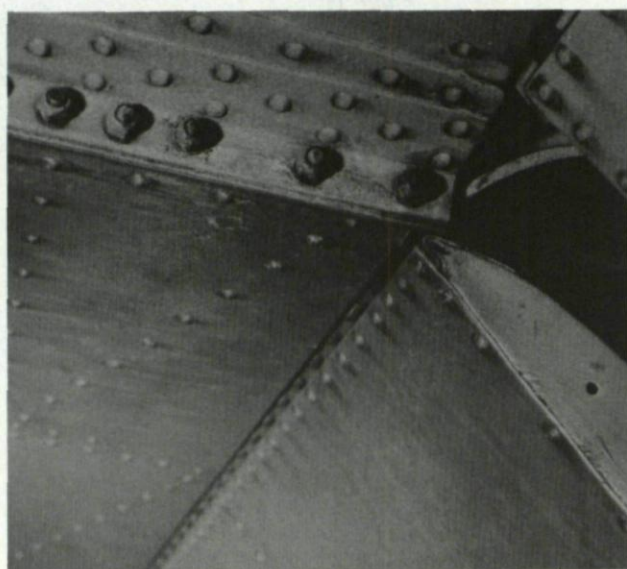
(b) and (c) Corrosion around bolts and under nuts in the under wing structure.

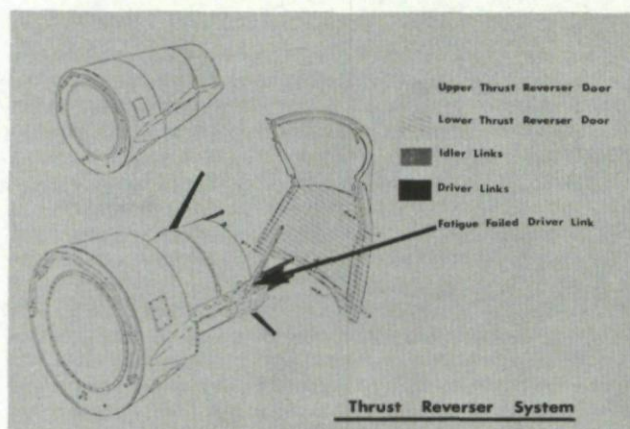
A large commercial jet lost the thrust reverser doors from one of its engines in cruise flight, but nevertheless landed safely. Subsequent investigation showed one thrust reverser door driver link had fractured, allowing the leading edge of the door to spring up into the 550 knot airstream. Figure 9-5(a) shows the general arrangement of the thrust reverser system with the failure location indicated by an arrow. The resulting air loads on the thrust reverser had torn the doors away from the aircraft. Closer inspection showed that the link failed in fatigue, but the fatigue crack initiated at pitting corrosion sites in the link surface. The latter was coated by a protective molybdenum disulphide type dry film lubricant. Figure 9-5(b) shows the broken driver links, with the primary fatigue fracture indicated by arrows.

- (a) General arrangement of thrust reverser system showing location of failure.
- (b) Broken driver links showing primary fatigue fractures (arrows).
- (c) Scanning electron microscope photograph of link surface near fracture, showing fissures in coating (black arrows). White arrows 'S' show cracks growing from pits 'P' in areas where coating has spalled off. Black arrows show fissures in coating. (Mag. $\times 100$)
- (d) Cross-section through a typical pit (P in Fig. 9-5(c)) showing depth of attack. Villela's etch. (Mag. $\times 200$)

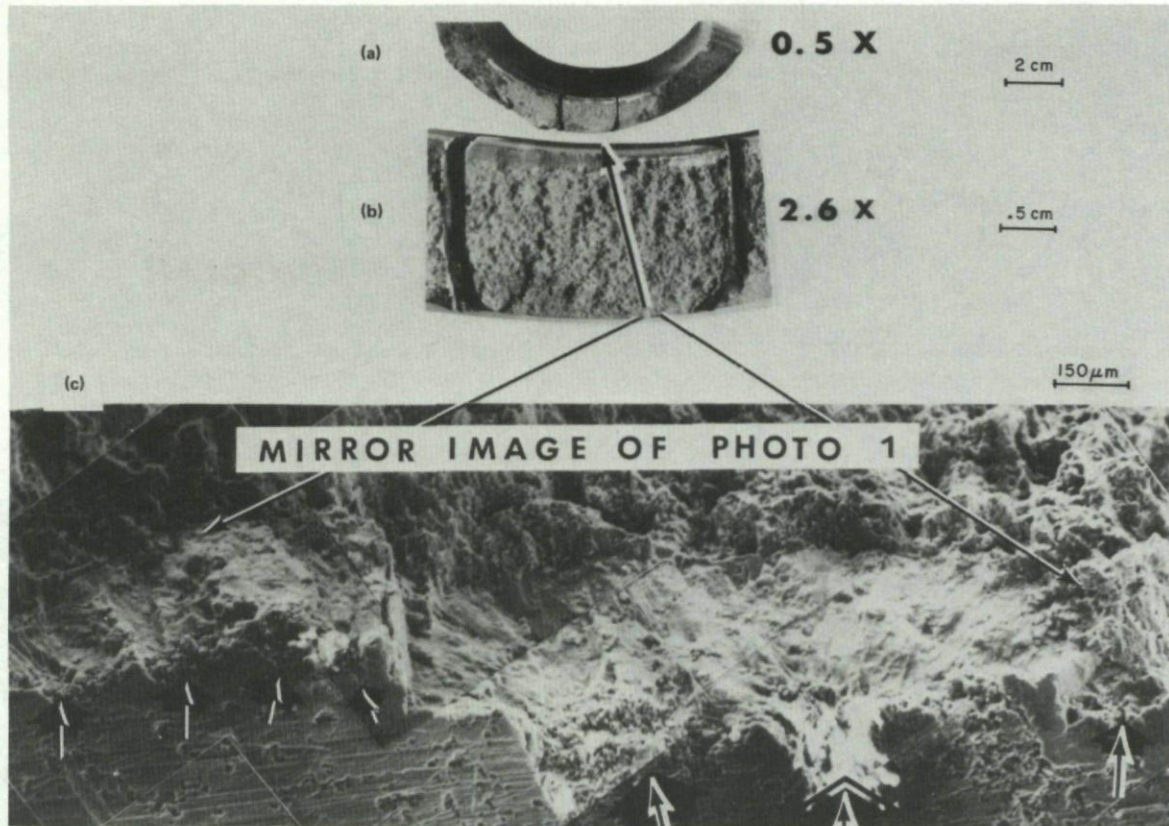
Within a one month period, three naval aircraft were damaged due to failure of their main landing gear struts. The failed struts were submitted for laboratory examination, which showed the strut outer barrel was fabricated from 2014-type aluminium alloy, and all were within the specified dimensional tolerances with respect to wall thicknesses.

Fig. 9-6 Pitting corrosion and fatigue of a 2014 aluminium alloy main landing gear strut

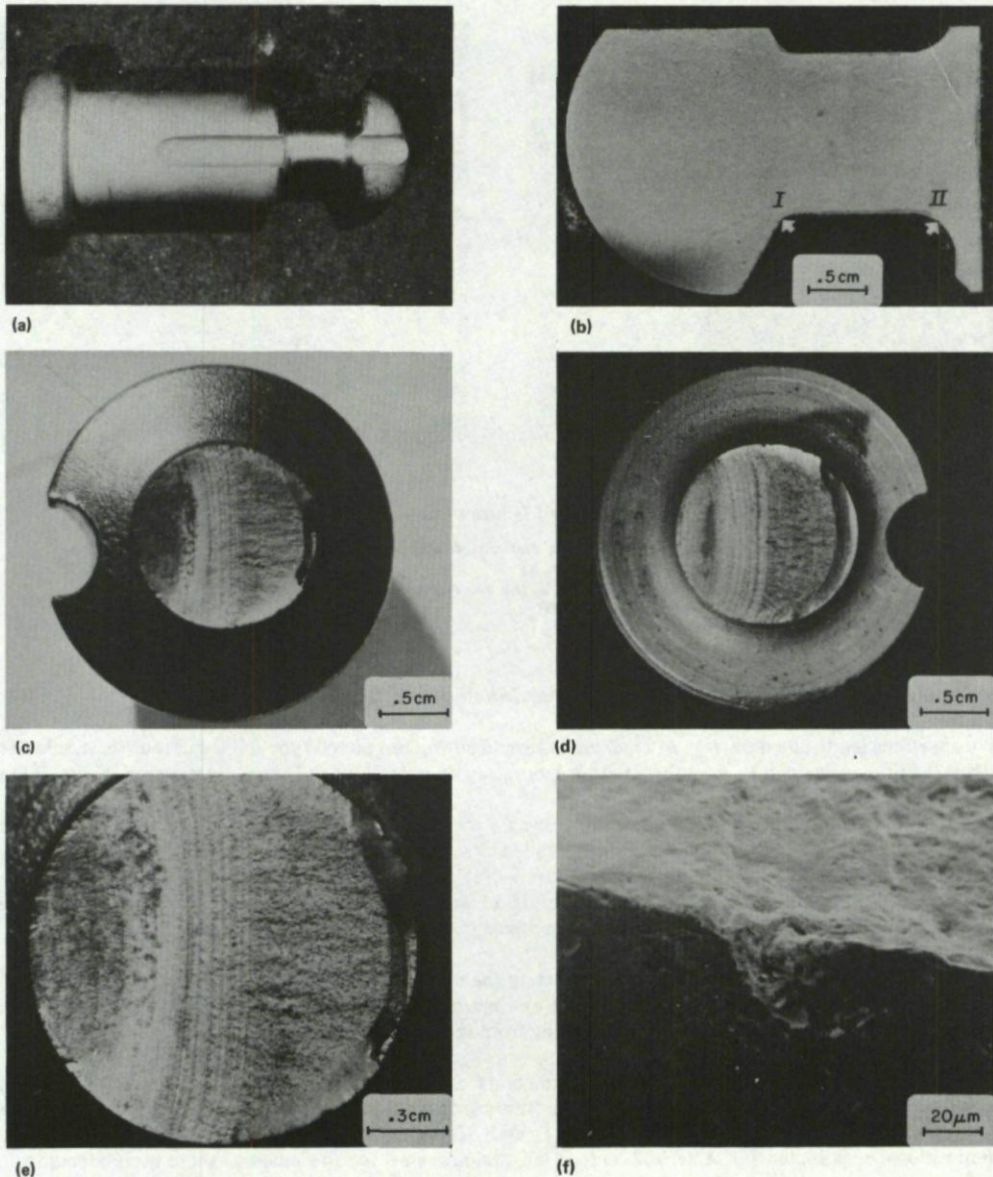
All of the failures initiated at the side of the latch knobs facing towards the wing lower side, and in every failure almost half the cross-section showed a fatigue fracture surface. An investigation with the scanning electron microscope revealed that the failures were initiated by corrosion pits. This is illustrated in Figure 9-7(f), showing a corrosion pit at the origin of one of the fatigue fractures.

Fig. 9-7 Pitting corrosion and fatigue failure of a 4340 steel tip tank latch knob

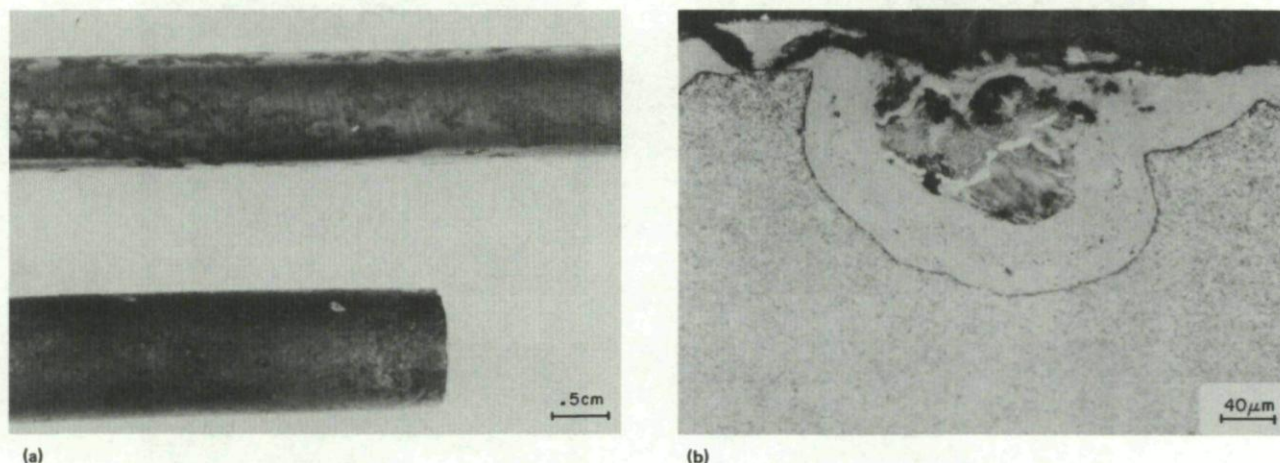
A light single engine aircraft suffered in-flight engine failure and was destroyed in the subsequent forced landing. Engine teardown revealed engine seizure was the result of an exhaust valve failure. The valve stem fractured in fatigue, the crack initiating at pitting corrosion sites on the valve stem. The push rod also showed extensive pitting corrosion. Both parts are shown in Figure 9-8(a).

Figure 9-8(b) shows a typical pit in the valve stem, filled with a complex series of corrosion products containing iron, chromium and silicon oxides, and aluminium, copper, lead, sulphur and bromine compounds. Pitting near the fracture was so severe as to overlap the pits and reduce the section diameter by approximately 0.25 mm. Since this engine continued to run for some time after the valve head had separated and had fallen into the cylinder head, extensive secondary damage resulted from the valve head ingestion and eventually seized the engine.

Teardown revealed extensive pitting of several other valves and push rods. The engine was found to have been inactive for long periods, during which the engine oil was not drained and replaced by inhibiting oil. This improper maintenance resulted in pitting corrosion of the valves and push rods from acid compounds formed in the old engine oil.

Fig. 9-8 Pitting induced failure of an engine exhaust valve

- (a) Pitted push rod (top) and pitted and fatigue fractured valve stem (bottom). (Mag. $\times 2$)
 (b) Typical corrosion pit in the valve stem near the fracture face. Nital etch. (Mag. $\times 250$)

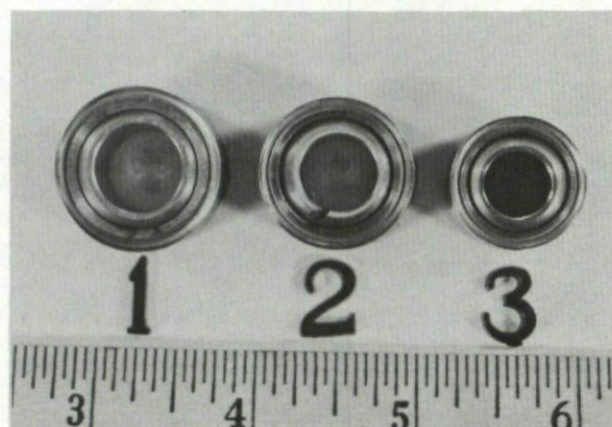
Visual inspections led to the discovery of cracking in several chromium plated type 440C martensitic stainless steel wing flap hinge bearings. Three of the suspect parts were submitted for laboratory examination, and these are shown in Figure 9-9(a).

- (a) Three hinge bearings from a fighter aircraft.
- (b) Bearing number 1, showing crack configuration.
- (c) Bearing number 2, showing crack pattern and fragment missing at end of crack.
- (d) Fracture face of second crack in bearing number 1. Arrow shows probable crack initiation area. (Mag. $\times 5$)
- (e) Corrosion pits on the inner diameter of a bearing which are typical of all three bearings submitted. (Mag. $\times 20$)
- (f) Cross-section of corrosion pit found on bearing showing intergranular cracking at the base of the pit. Picric acid etch. (Mag. $\times 500$)

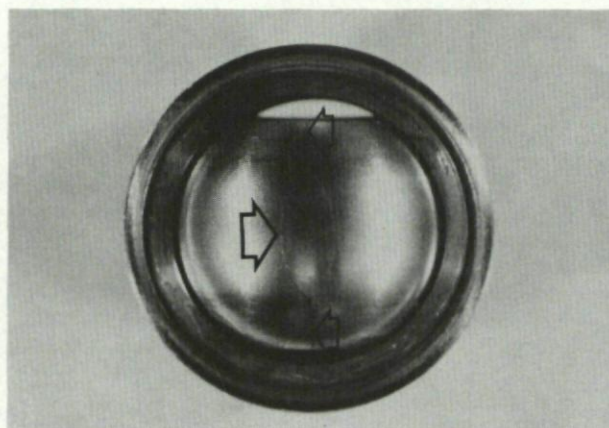
(b)

Bearings 1 and 2 were found to be cracked, while bearing 3 was found to be uncracked. In bearing No. 1, two separate cracks were found; one crack took the path shown in Figure 9-9(b), while the second crack, which is not shown, ran straight across the bearing cross-section. Bearing No. 2 showed the crack path seen in Figure 9-9(c). Further visual examination of the bearing crack fractures showed the cracks were flat and slightly fibrous, as indicated in Figure 9-9(d). The fracture face of bearing No. 2 differed slightly from the two fractures seen on bearing No. 1 in that there was a chip missing on the outer edge of the bearing.
